**Flood Control Project Maintenance  
Levee Inspections**

**Maintenance Issue Types Only, Levee Inspection Report By Mile - Spring 2019**

**Sutter Maintenance Yard East Levee Sacramento River**

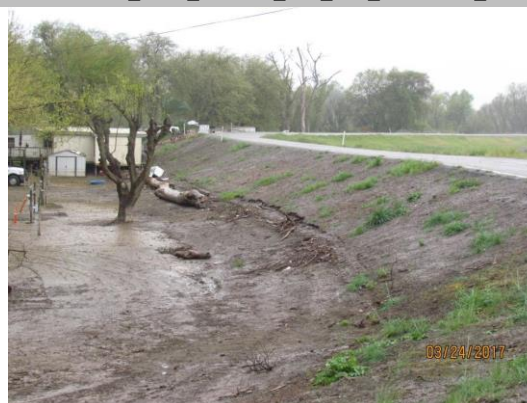
Photo 1 of 1 : SP\_2019\_ST0003\_264\_130\_20190327\_00032.jpg

View of the erosion along the waterside slope.

| Repair the erosion along the waterside slope. | | | | | |

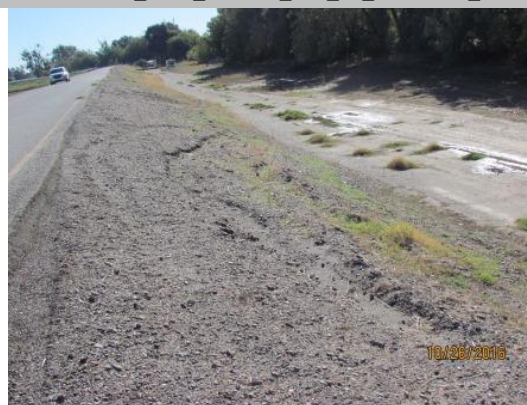
Photo 1 of 1 : SP\_2019\_ST0003\_264\_81\_20190327\_00018.jpg

View of the ruts along the waterside slope.

| S3 : Repair the levee slope damaged by vehicle traffic and prevent access where possible. | | | | | |

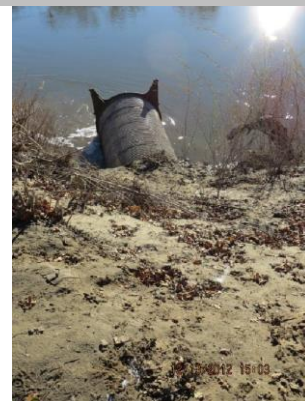
Photo 2 of 3 : UCIP\_SP\_2019\_51650\_46960.jpg

Waterside view: water flowing from CMP sewer pipe

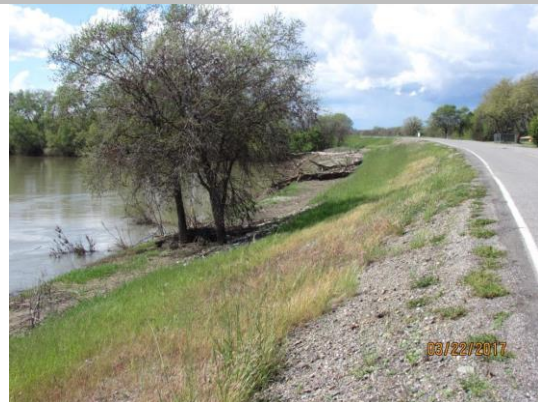
Photo 1 of 1 : SP\_2019\_ST0003\_264\_9\_20190327\_00007.jpg

View of the debris along the waterside slope.

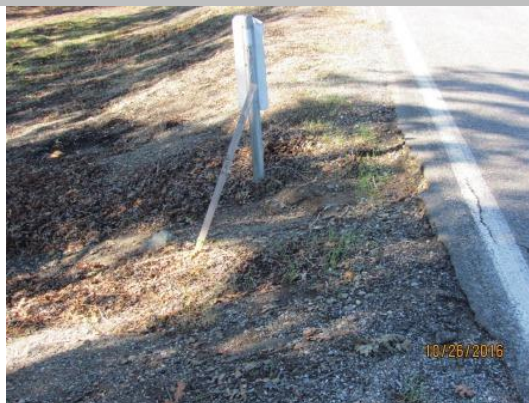
Photo 1 of 1 : SP\_2019\_ST0003\_264\_80\_20190327\_00017.jpg

View of the slope instability along the waterside slope.

| S1 : Repair slope instability. | | | | | |

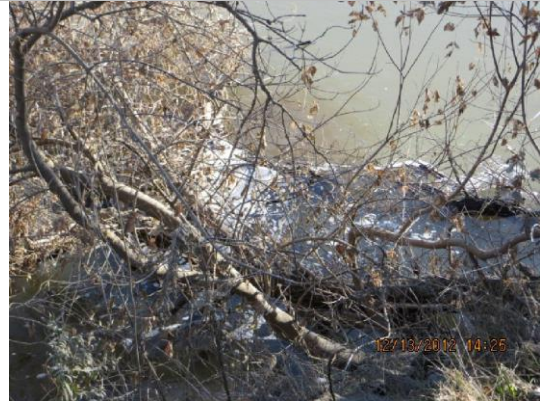
Photo 2 of 3 : UCIP\_SP\_2019\_53400\_46991.jpg

FS\_ID:53400  
DS\_ID:17320  
EP\_NO: 9543  
Repair Type: Urgent  
Crossing Status: Found  
UCIP Comments: 8/30/2018 WS vegetation too thick to clearly inspect WS pipe so assume same condition as last inspections so crossing remains Urgent due to pipe integrity. WS levee slope looks good. No signs of levee threat to the road crown. LS headwall looks in good condition (D. Sanoski - DWR UCIP).4/24/2017 WS was underwater during the site visit but I do not believe that any repairs have been made to this crossing yet. (DWR Sutter Yard- AFreitag)11/7/2016 No repairs have been made here yet. (DWR Sutter Yard- AFreitag)6/17/2016 River levels were down and the WS pipe end was exposed. WS end is completely rotten and damaged and flap gate has fallen off the end of the pipe (see pics). Pipe needs to be replaced or repaired. (DWR Sutter Yard - afreitag)4/5/2016 Erosion on WS slope still present. Pipe still fully submerged on WS and discharging into river during site visit. (DWR UCIP - kfazel)4/6/2015 Pipe leaks during high water. DWR employee said he suspects that the flap gate has rotted and fallen off WS end of pipe. Could not locate WS end of pipe to confirm. Water was flowing through this drain during field survey. (DWR Sutter Yard - afreitag)6/30/2014 Same as last inspection. (DWR Sutter Yard - afreitag)12/30/2013 Same as last inspection. (DWR Sutter Yard - afreitag)7/29/2013 Same as last inspection. (DWR Sutter Yard - afreitag) 12/13/2012 Water was flowing through this drain during field survey. (DWR UCIP - pamatya)

FIELD\_STRUCT\_DESC: 30-inch corrugated metal drainage pipe (at 45 degrees) through the levee, 25.2 feet below the crown. Flap gate on the waterside (WS), not found in 2016. (30-inch pipe [HLM 1.38] authorized under Automatic Board Order (ABO) issued as Permit No. 9543, 1974 - Harada). [Additional Reference(s): DWR Levee Log, 2002. USACE Sacramento O&M Manual 136, revision March 1960 (HLM 1.38)]  
FS Date: 8/30/2018 1:02:00 PM

Waterside view: water flowing from outlet pipe (pipe fully submerged)

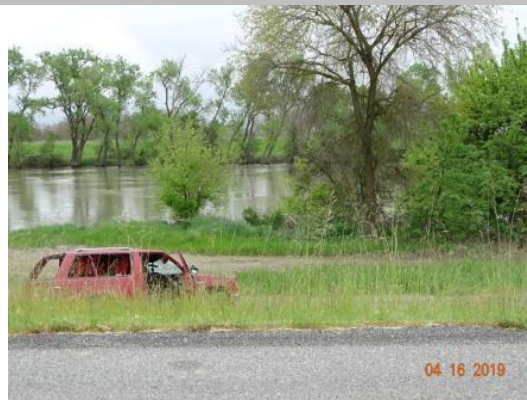
Photo 1 of 1 : SP\_2019\_ST0003\_264\_88\_20190418\_00187.jpg

View of the abandoned vehicle on the waterside slope. Spring 2019.

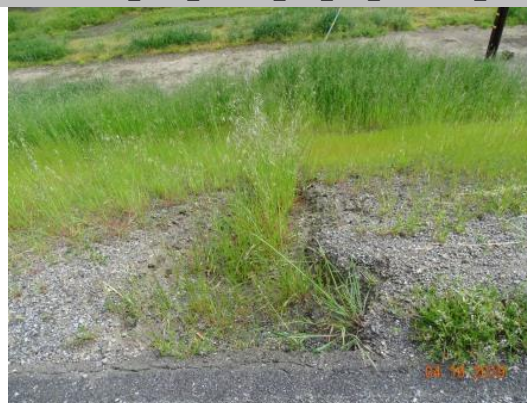
Photo 1 of 1 : SP\_2019\_ST0003\_264\_103\_20190418\_00188.jpg

View of the erosion on the landside slope. Spring 2019.

| E2 : Schedule repair of erosion site prior to the next inspection. | | | | | |

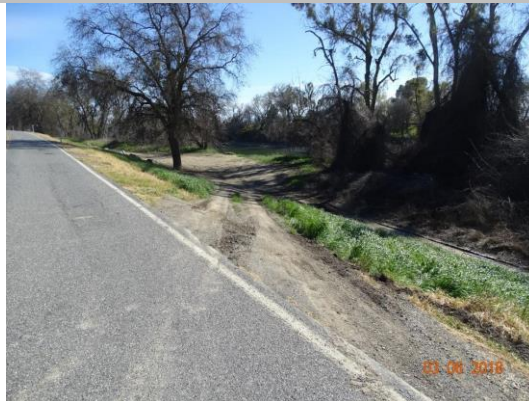
Photo 1 of 1 : SP\_2019\_ST0003\_264\_104\_20190327\_00027.jpg

View of the erosion along the waterside slope caused by vehicle traffic.

| S3 : Repair the levee slope damaged by vehicle traffic and prevent access where possible. | | | | | |

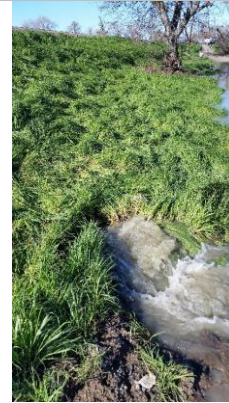
Photo 1 of 3 : UCIP\_SP\_2019\_52949\_76919.jpg

| FS_ID:52949<br>DS_ID:17311<br>EP_NO: N/A<br>Repair Type: Urgent<br>Crossing Status: Found<br>UCIP Comments: 8/30/2018 Pipe found; at a different Lat/Long than is listed, however. Revised Lat/Long is (39.196865, -121.985280; CLM 3.32). WS pipe end is visible and has a functioning slide gate; LS pipe end is exposed with no closure device or headwall. Keeping as Urgent because the LS pipe discharges into a hole and could pose a threat to the levee prism during a high water event. There are also cracks on the crown that could be related to the pipe beneath. Recommend an internal pipe inspection to be sure of the levee integrity (D.Sanoski - DWR UCIP).4/6/2017 Pipe was found in January 2017 during a high water event when water uncovered the buried WS end which led to uncontrolled water flow through during the high water event. The WS pipe opening was temporarily blocked off by plywood and sandbags until the pipe can be properly plugged or abandoned. Pics updated. (DWR Sutter Yard- Afreitag)11/7/2016 Unable to locate. (DWR Sutter Yard- AFreitag)6/6/2016 Unable to locate.4/6/2015 Unable to locate.6/30/2014 Unable to locate.12/30/2013 Unable to locate.7/29/2013 Same as last inspection. Unable to locate. FIELD_STRUCT_DESC: 24-inch corrugated metal drainage pipe through the levee, 12.4 feet below the crown. Slide gate on the waterside (WS) end. (Automatic Board Order (ABO) issued as Permit No. 9539, 1974 - Locvich). [Additional Reference(s): DWR Levee Log, 2002. USACE Sacramento O&M Manual 136, March 1960 (HLM 3.25)]. FS Date: 8/30/2018 1:45:35 PM | | | | | | |

LS view of water exiting the pipe.

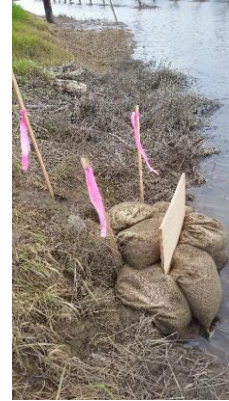
Photo 3 of 3 : UCIP\_SP\_2019\_52949\_76921.jpg

WS view of the temporary plug on WS end.

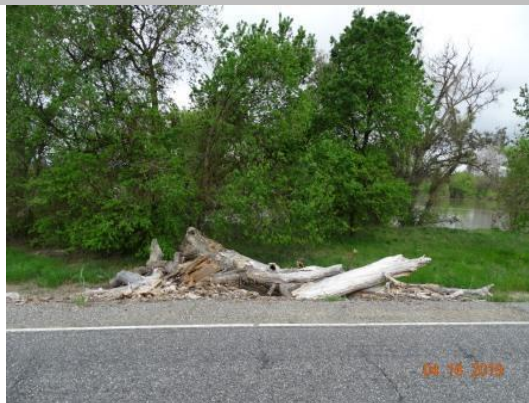
Photo 1 of 1 : SP\_2019\_ST0003\_264\_108\_20190418\_00189.jpg

View of the tree on the waterside slope. Spring 2019.

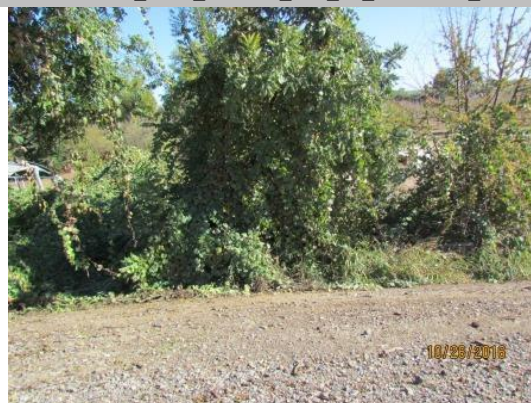
Photo 1 of 1 : SP\_2019\_ST0003\_264\_99\_20190327\_00024.jpg

View of the overgrown vegetation along the landside slope.

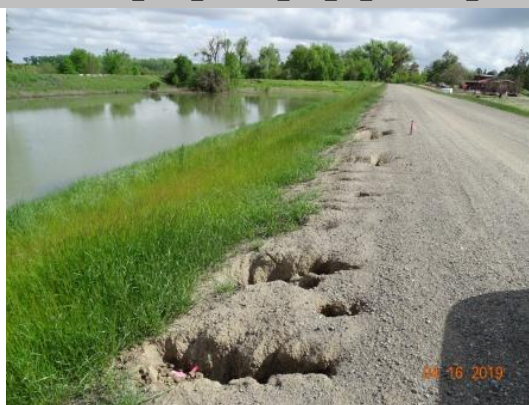
Photo 1 of 1 : SP\_2019\_ST0003\_264\_97\_20190418\_00190.jpg

View of rodent activity, erosion and caving on the waterside slope and shoulder. Spring 2019.

| Notes: Rodent activity seems to be the source of the problem. Local runoff/rainfall eroded the rodent holes to an advanced state of erosion that could continue with future exposure to wet conditions. Simple fix for the issue would be to grout the holes. Problem levee is a set-back levee. | | | | | |

| S1 : Repair slope instability. | | | | | |

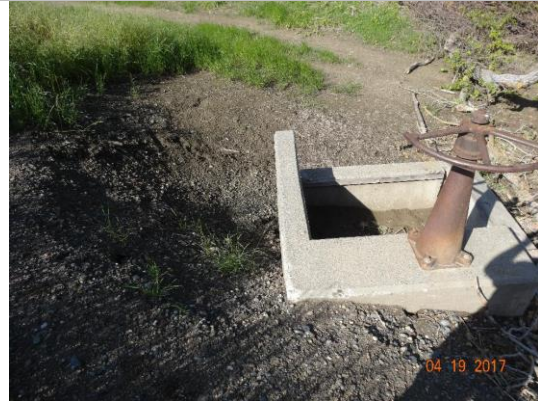
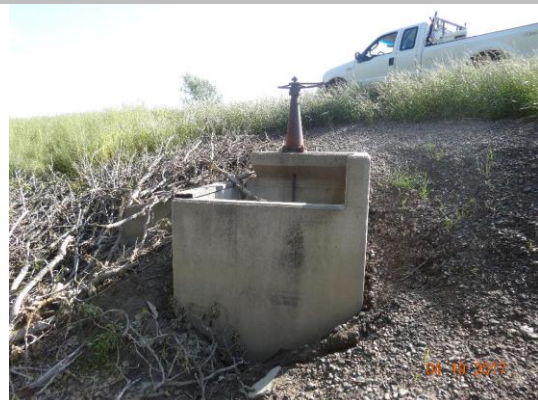
| FS_ID:51695<br>DS_ID:17301<br>EP_NO: 9532<br>Repair Type: Non-Urgent<br>Crossing Status: Found<br>UCIP Comments: 4/19/2017 Abandoned- erosion/depression present around the WS box (DWR Sutter Yard- AFreitag)10/31/2016 Abandoned and erosion still present near WS box.(DWR Sutter Yard- AFreitag)6/1/2016 Appears to be an abandoned crossing.4/1/2015 Silted concrete box on WS. Depression/erosion around concrete box on WS.Silted concrete box on WS. Depression/erosion around concrete box on WS.6/30/2014 Same as last inspection.12/18/2013 Same as last inspection.7/23/2013 Same as last inspection.<br>FIELD_STRUCT_DESC: *ABANDONED* 36-inch by 48-inch reinforced concrete box drainage culvert through the levee, 11.6 feet below the crown. Slide gate in a concrete box on the waterside (WS) slope. (3-foot by 4-foot culvert [HLM 7.73] authorized under Automatic Board Order (ABO) issued as Permit No. 9532, 1974 - Martin). [Additional Reference(s): DWR Levee Log, 2002. USACE Sacramento O&M Manual 136, March 1960 (HLM 7.73)].<br>FS Date: 4/26/2017 2:38:29 PM | | | | | |

Depression around WS concrete box

depression around WS concrete box

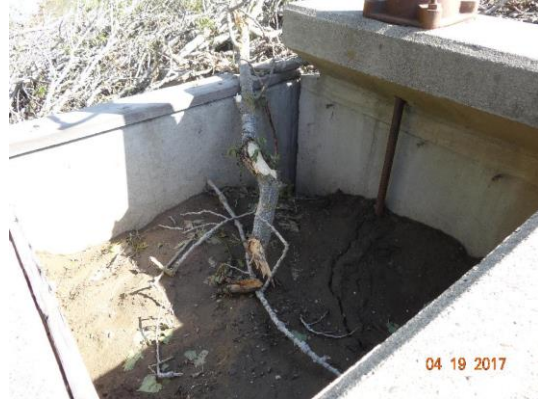
Photo 3 of 3 : UCIP\_SP\_2019\_51695\_77010.jpg

WS concrete box full of silt.

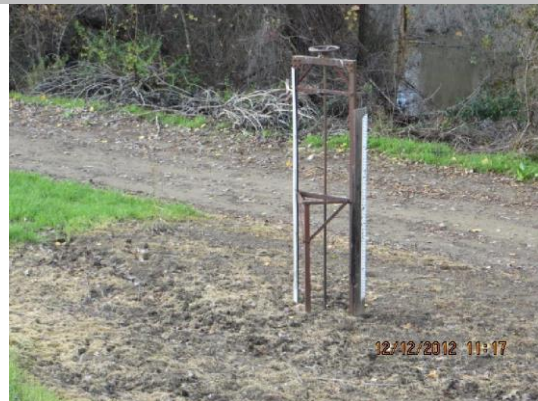
Photo 2 of 3 : UCIP\_SP\_2019\_51726\_47209.jpg

Waterside view: buried slide gate

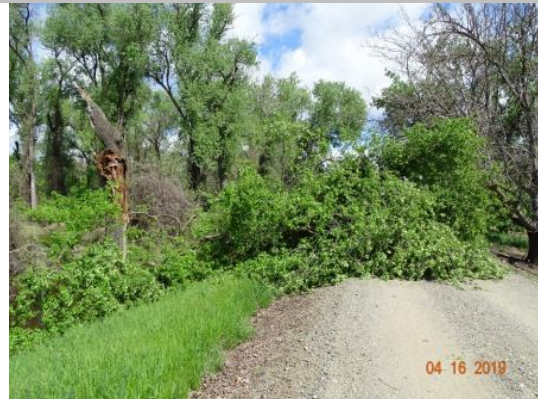
Photo 1 of 1 : SP\_2019\_ST0003\_264\_119\_20190418\_00191.jpg

View of a large fallen tree blocking access. Spring 2019.

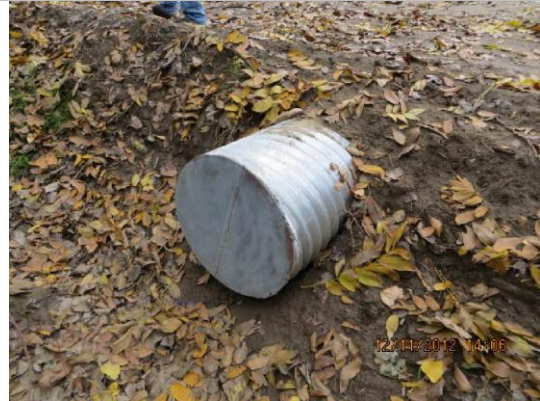
Photo 3 of 3 : UCIP\_SP\_2019\_51731\_47240.jpg

Waterside view: capped CMP pipe

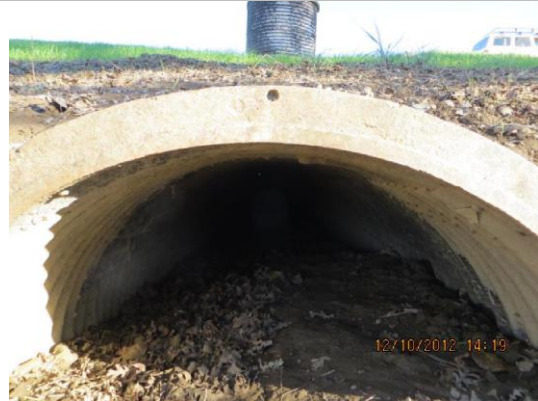
Photo 3 of 3 : UCIP\_SP\_2019\_51749\_47341.jpg

Waterside view: silted concrete lined CMP outlet pipe

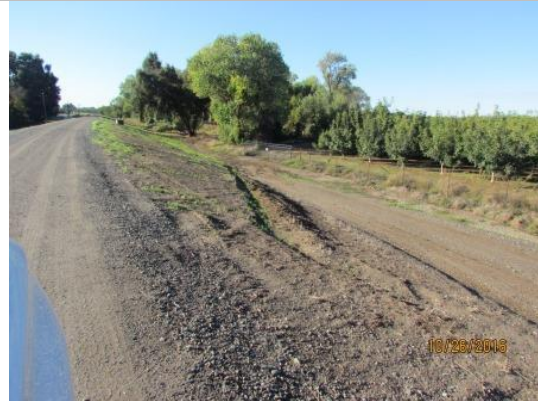
Photo 1 of 1 : SP\_2019\_ST0003\_264\_75\_20190327\_00015.jpg

View of the slope instability along the waterside slope.

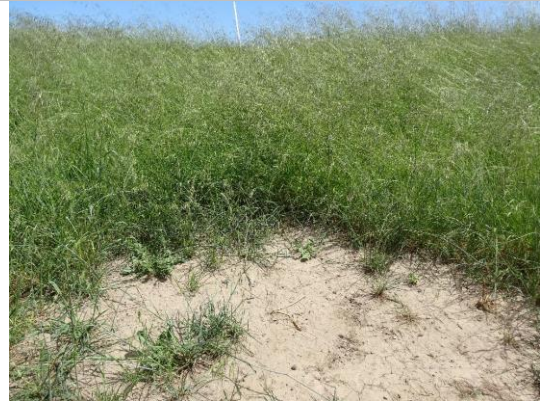
Photo 3 of 3 : UCIP\_SP\_2019\_51759\_75098.jpg

Looking up WS slope: bare spot where pipe was previously excavated, video inspected, and backfilled.

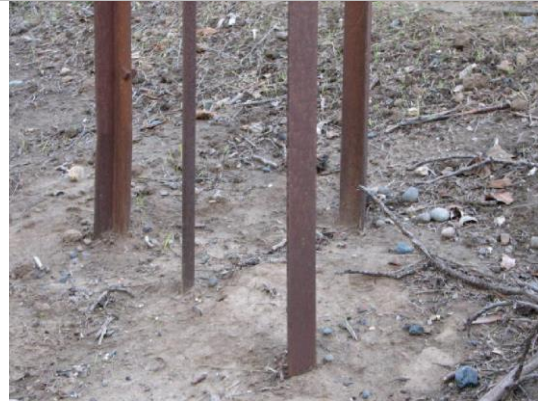
Photo 3 of 3 : UCIP\_SP\_2019\_51762\_47385.jpg

Waterside view: buried slide gate

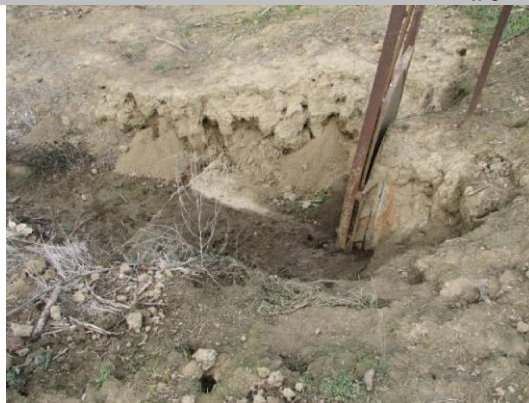
Photo 3 of 3 : UCIP\_SP\_2019\_51770\_47403.jpg

Waterside view: sloughing at outlet pipe

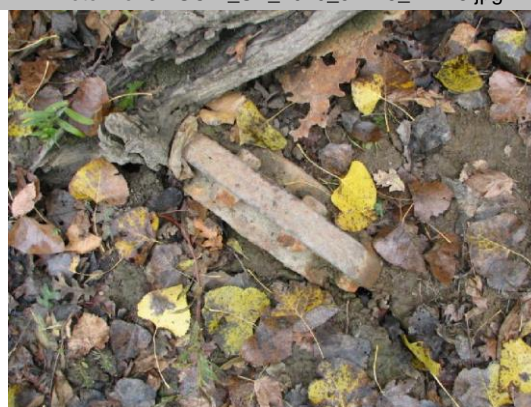
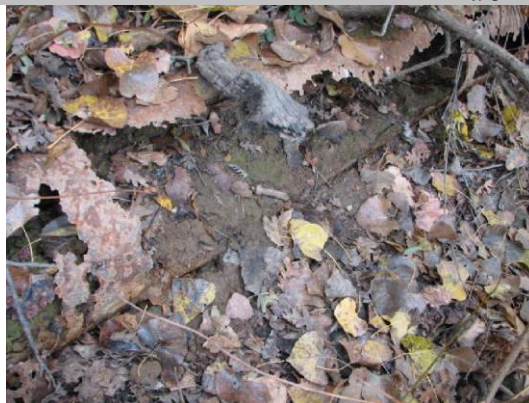
Waterside view: abandoned and ruined pipe

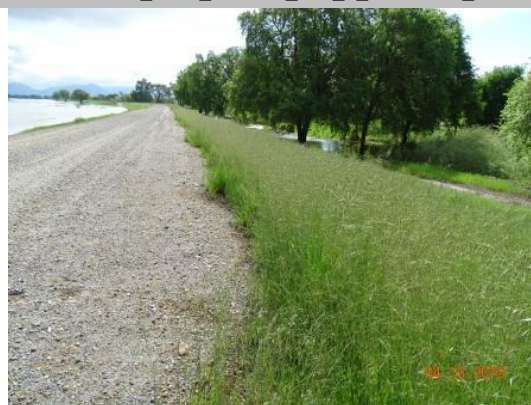
Photo 1 of 1 : SP\_2019\_ST0003\_265\_7\_20190418\_00004.jpg

View of the vegetation on the landside slope. Spring 2019.

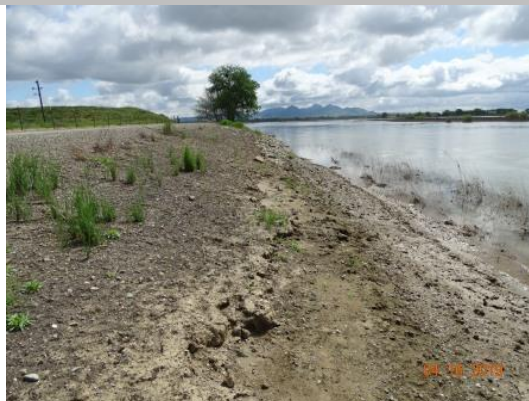
Photo 1 of 1 : SP\_2019\_ST0003\_266\_3\_20190418\_00001.jpg

View of the erosion on the waterside slope and toe. Spring 2019.

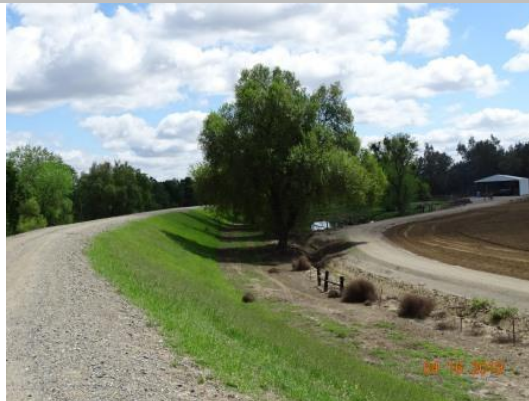
Photo 1 of 1 : SP\_2019\_ST0003\_267\_1\_20190418\_00001.jpg

View of the vegetation on the landside slope. Spring 2019.

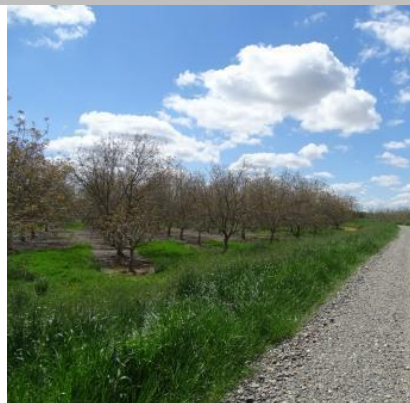
Photo 1 of 1 : SP\_2019\_ST0003\_268\_2\_20190418\_00003.jpg

View of the vegetation on the landside slope. Spring 2019.
